PUBLIC ROADS

A JOURNAL OF HIGHWAY RESEARCH

VOL. 22, NO. 8

<i>Page</i>
Stabilization of Gravel Runways on Washington National Airport	167
Lignin Binder Used in Test Sections Subjected to Accelerated Traffic	183
Possible Substitutes for Aluminum Paint	189
Disposition of State Motor-Fuel Tax Receipts, 1940	193
Disposition of State Motor-Vehicle Receipts, 1940	194
Disposition of State Motor-Carrier Tax Receipts, 1940	195
Disposition of Receipts From State Imposts on Highway Users, 1940	196

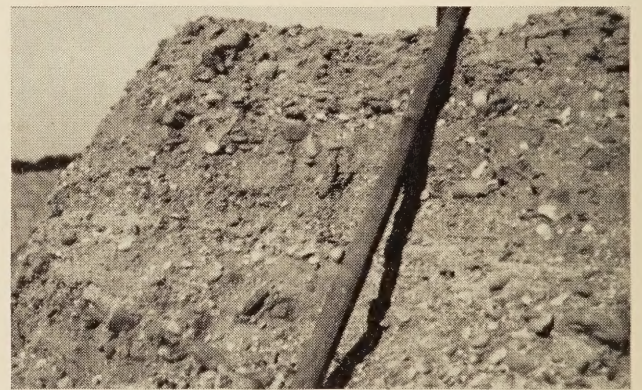
FIGURE 3.—TYPICAL FORMATION OF GRAVEL DEPOSITED BY PUMPING OPERATIONS.

The character of the gravel formations as deposited by the pumping operations is illustrated in figure 3. Tests performed on samples taken from the upper 12 inches of the runways (see table 1) indicated that the material, in general, was a nonplastic mixture of sand and gravel with variable amounts of large rock and

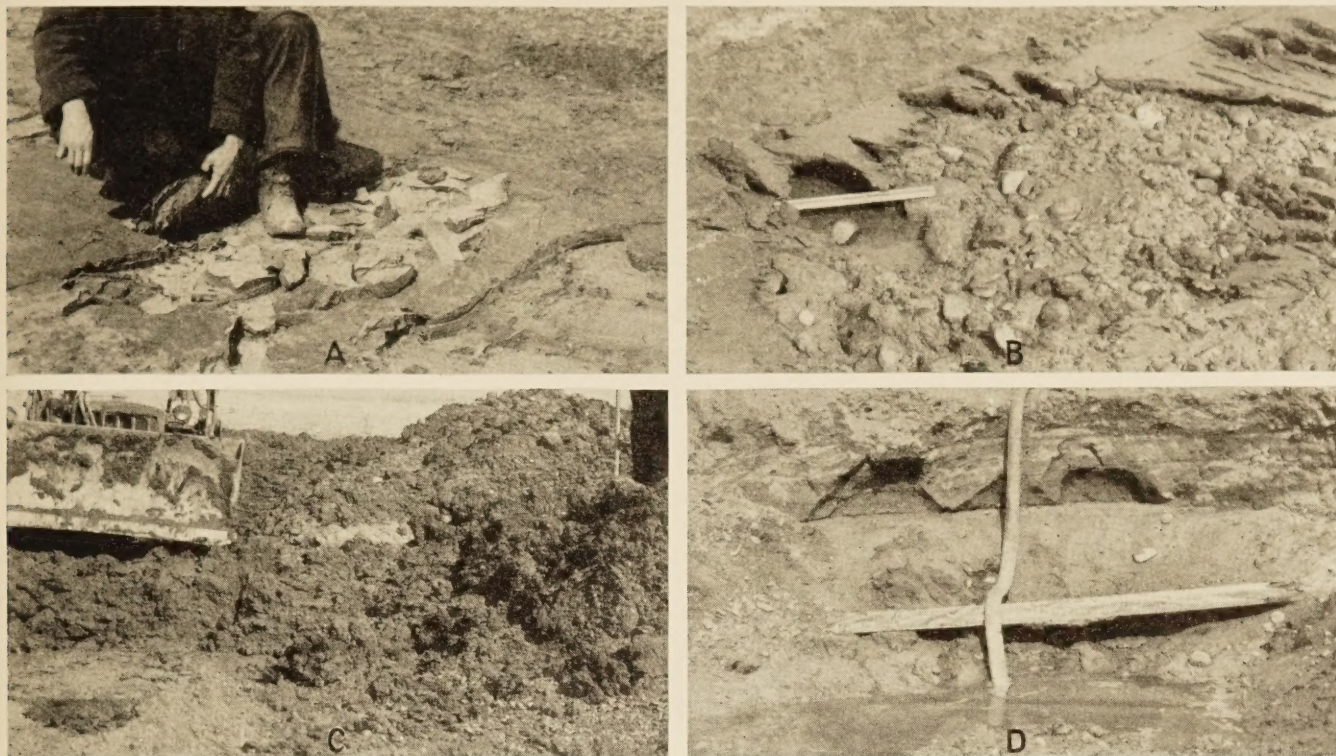
FIGURE 4.—TYPICAL EXAMPLES OF POCKETS AND LAYERS OF MUCK AND SAND. A, THIN LAYERS OF MUCK; B, POCKET OF MUCK, GRAVEL, AND ENTRAPPED WATER; C, DEEP POCKET OF SOFT MUCK; AND D, SANDY DEPOSIT WITH THIN LAYERS OF MUCK.

In addition to variations in the amount of large rock in the gravel fill, layers and pockets of muck and fine sand were encountered in many locations. These conditions are illustrated in figure 4. Mechanical analyses and physical properties typical of these materials are given in table 2.

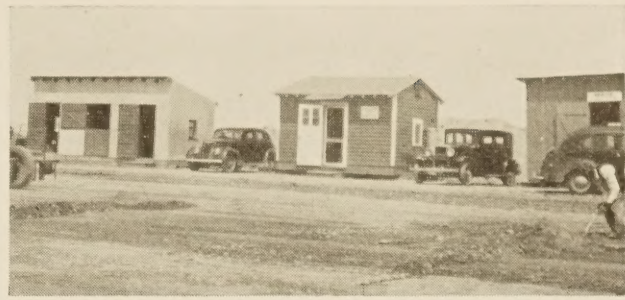
FIGURE 7.—PORTABLE LABORATORY (CENTER) AND OFFICES ON RUNWAYS.

Control over the base stabilization in accordance with these requirements was accomplished by coordinating the construction operations with the tests performed on the raw materials and the mixtures. This work was directed from a portable field laboratory (fig. 7) located on the runways.

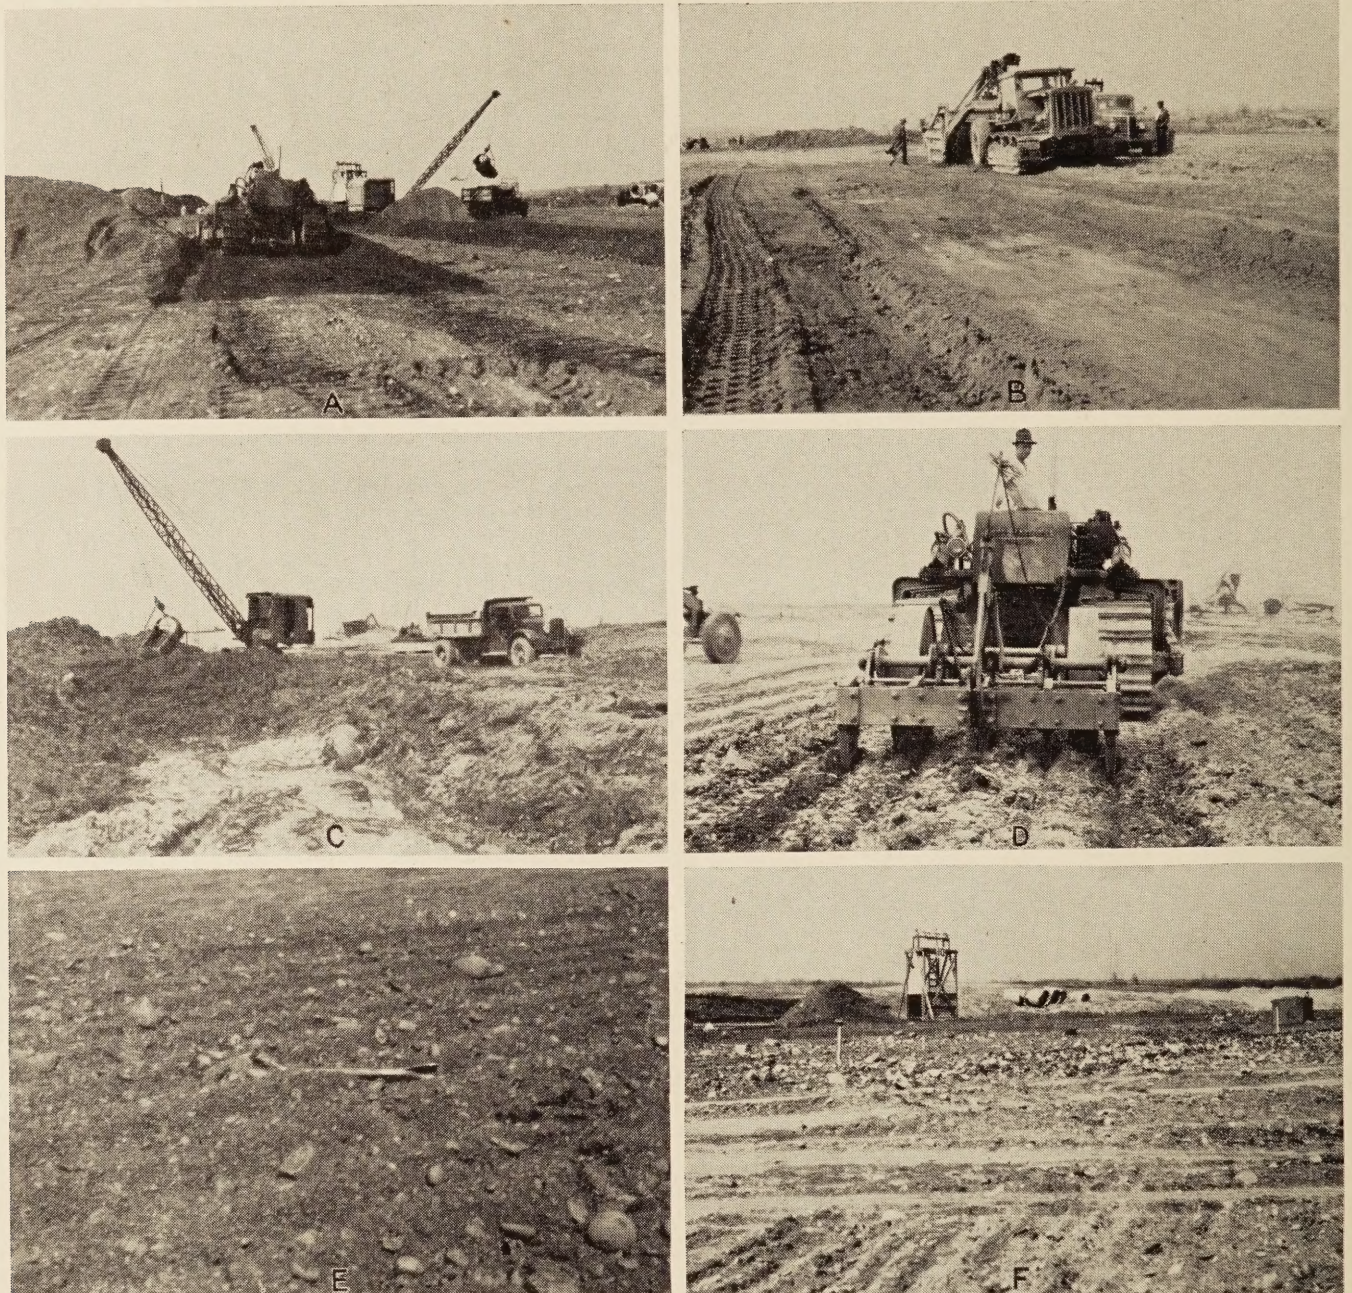
FIGURE 8.—CONSTRUCTION OF RUNWAYS: A, GRADING OPERATIONS; B, THIN LAYERS OF MUCK BEING EXCAVATED BY SCRAPER; C, DEEP MUCK BED BEING EXCAVATED BY DRAGLINE; D, SCARIFYING MATERIAL WITH HEAVY-DUTY ROOTER; E, OVERSIZE STONE BROUGHT TO SURFACE BY SCARIFYING; AND F, OVERSIZE STONE IN EXCESSIVE AMOUNTS GENERALLY ENCOUNTERED AT RUNWAY INTERSECTIONS.

Many areas containing unstable mucky materials were encountered during the grading operations. When the muck was in the form of seams or thin layers, it was excavated by means of large tractor-drawn scrapers (fig. 8-B). Deep pockets were removed with draglines (fig. 8-C). All muck deposits were removed to a minimum depth of 3 feet below subgrade elevation and replaced with gravel.

After the grading was completed, the runway material was scarified with a heavy-duty roter (fig. 8-D) to an approximate depth of 12 inches. The scarified gravel was then further loosened with a field cultivator and all oversized stone brought to the surface (figs. 8-E and 8-F) were removed by hand. These operations were continued until the depth to be stabilized was, for all practical purposes, free of all stones larger than about 3 inches and other objectionable material such as clay balls.

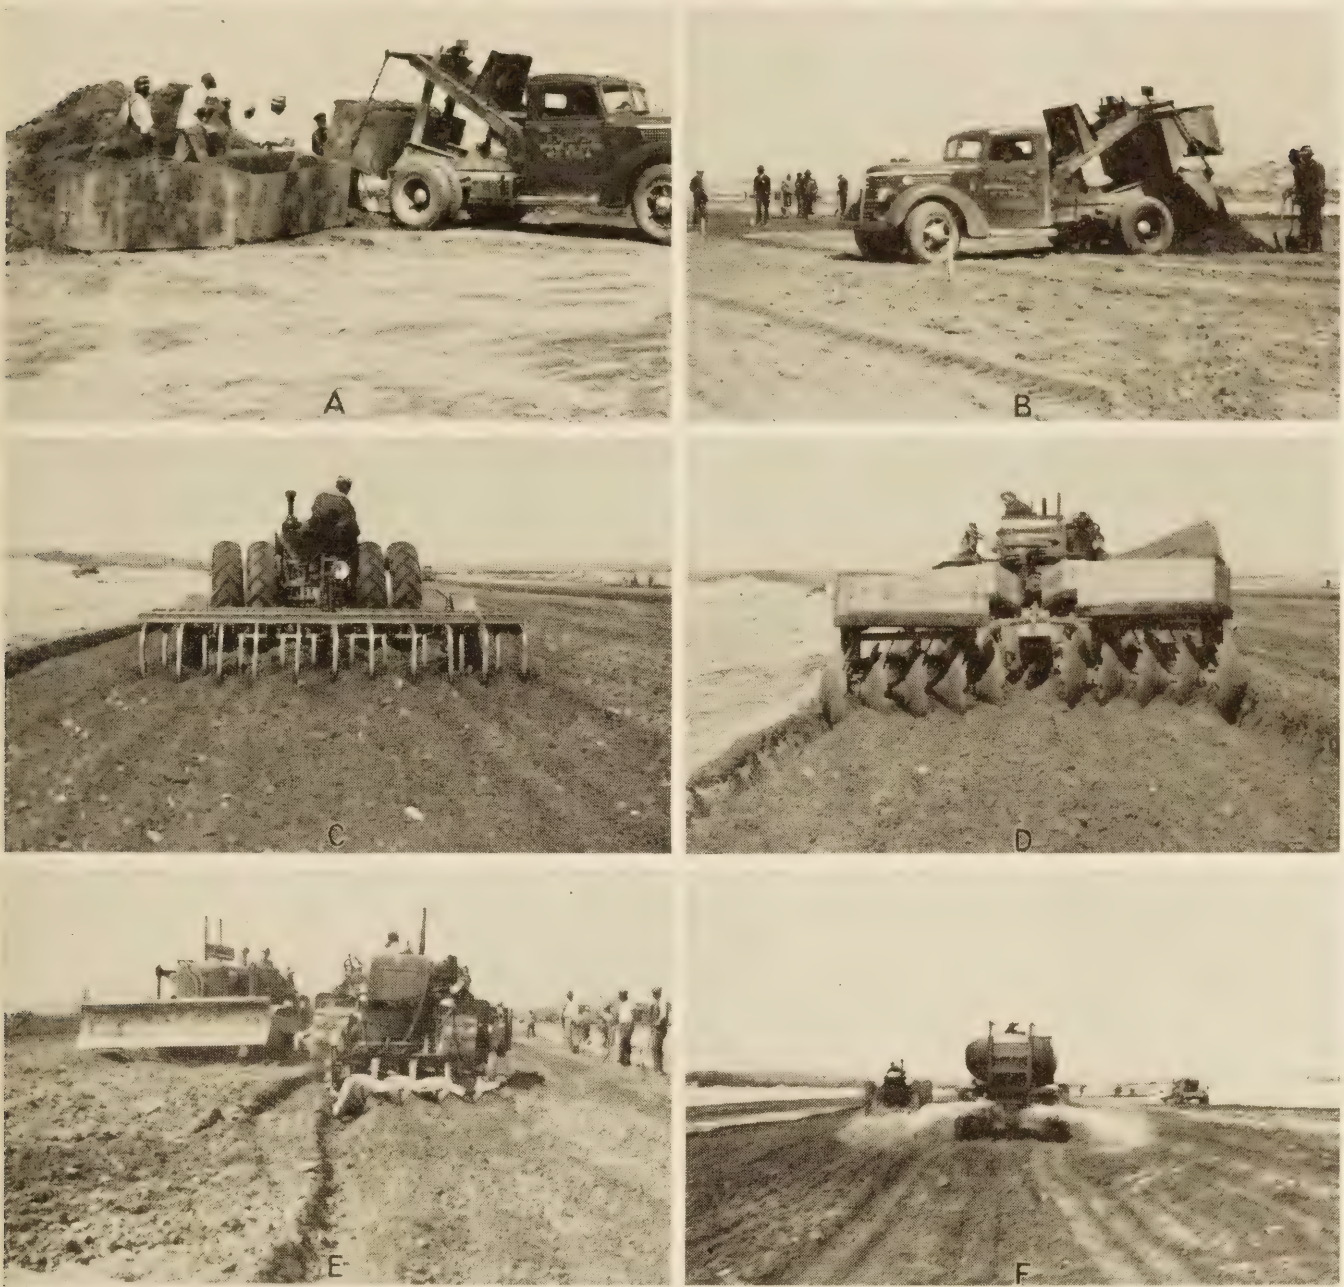
FIGURE 9.—STABILIZATION OF RUNWAYS: A, LOADING BINDER SOIL IN 2-CUBIC YARD BOXES; B, DEPOSITING AND SPREADING BINDER SOIL; C, CUTTING IN BINDER SOIL WITH FIELD CULTIVATOR; D, MIXING WITH TWO-WAY TANDEM DISK HARROW; E, TURNING DISKED MATERIAL WITH FOUR-BOTTOM GANG PLOW; AND F, SPRINKLING DURING MIXING OPERATIONS.

Water was applied (fig. 9-F) whenever necessary during the mixing operations. The need for water was determined by the requirements for compaction. Tests made on the base course material in locations where satisfactory compaction was obtained showed that 5 to 7 percent of moisture was required to give the desired results. This checked very closely with the optimum moisture content of 10 percent (American

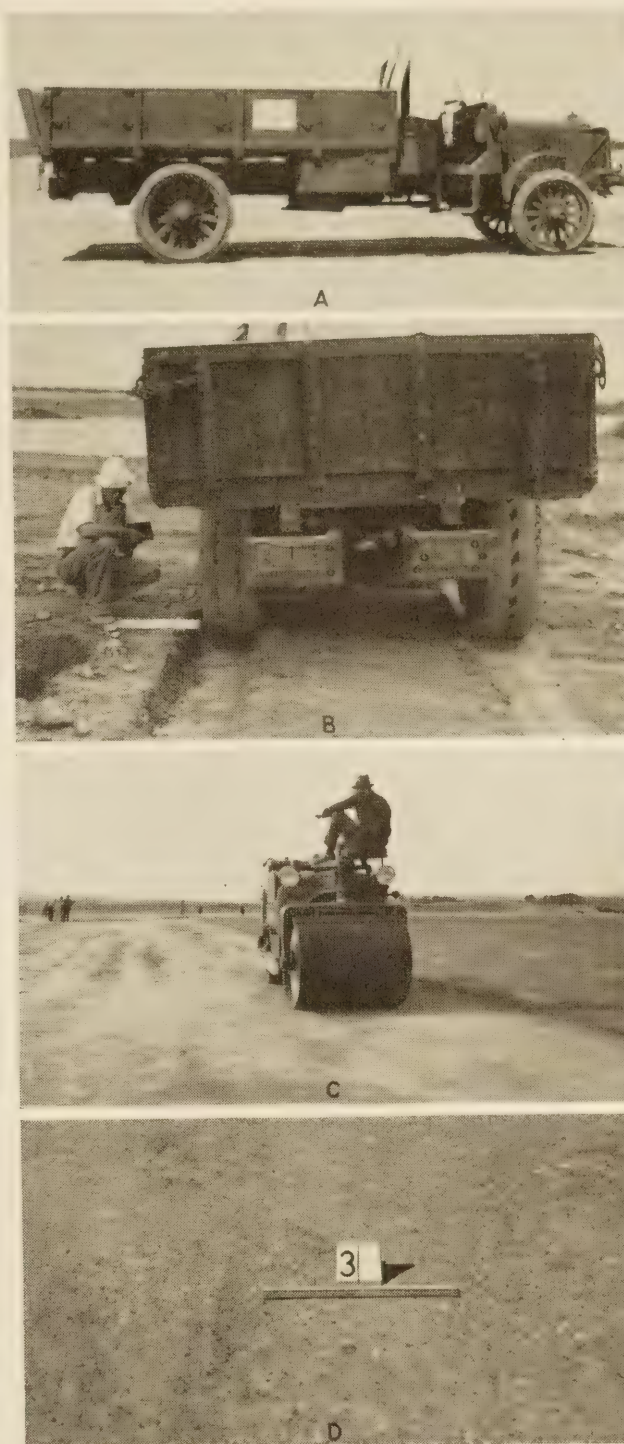
FIGURE 12 - A, CHECKING BASE STABILITY WITH A 12-TON, SOLID-TIRED TRUCK; B, FAILURE DUE TO WEAK SUBGRADE; C, FINAL ROLLING WITH AN 8-TON TANDEM ROLLER, AND D, APPEARANCE OF COMPLETED BASE COURSE.

Weak spots which developed in the base or subgrade during the rolling were examined by means of test pits and corrected according to the needs of the particular case. A further check on the subgrade stability was obtained by operating a 12-ton, solid-tired truck (fig. 12-A) over the compacted surface. A failure due to weak subgrade is shown in figure 12-B.

grade elevation at 25-foot intervals. This work was performed by hand or by motor patrol depending on the size of the area to be corrected. The surface was then finished by rolling with an 8-ton tandem roller (fig. 12-C). The appearance of the completed base course is shown in figure 12-D.

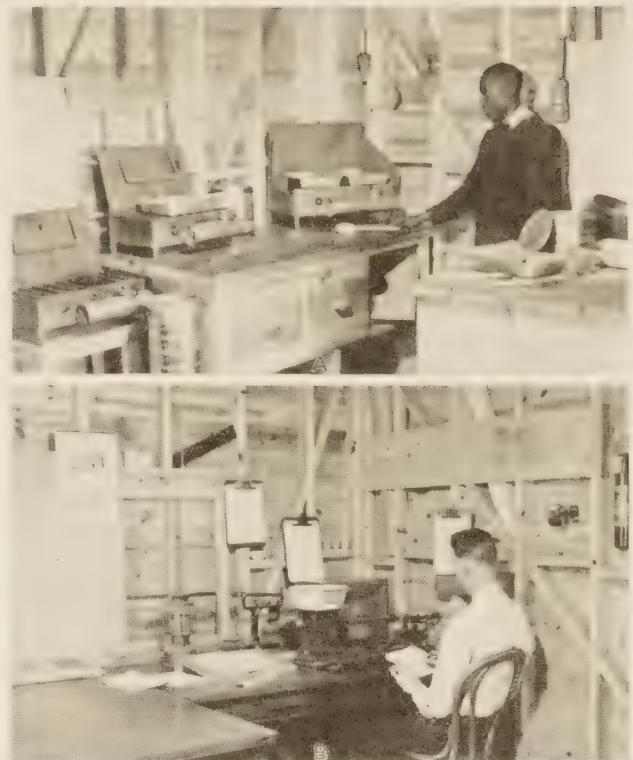
FIGURE 15.—LABORATORY TESTS ON SAMPLES. A, DRYING GRAVEL SAMPLES ON DOUBLE-BURNER GASOLINE CAMP STOVES; AND B, DETERMINING WEIGHTS OF MATERIAL RETAINED ON VARIOUS SIEVES.

The sample was first dried in shallow pans over a gasoline camp stove (fig. 15-A); it was stirred continuously to prevent burning. After the dried sample had cooled off, it was quartered down to about 4 pounds, placed in a pan, and ground with a rubber-covered pestle to break up the aggregation of particles. Any fine material having a tendency to adhere to the coarse gravel was removed with a wire brush. All of the

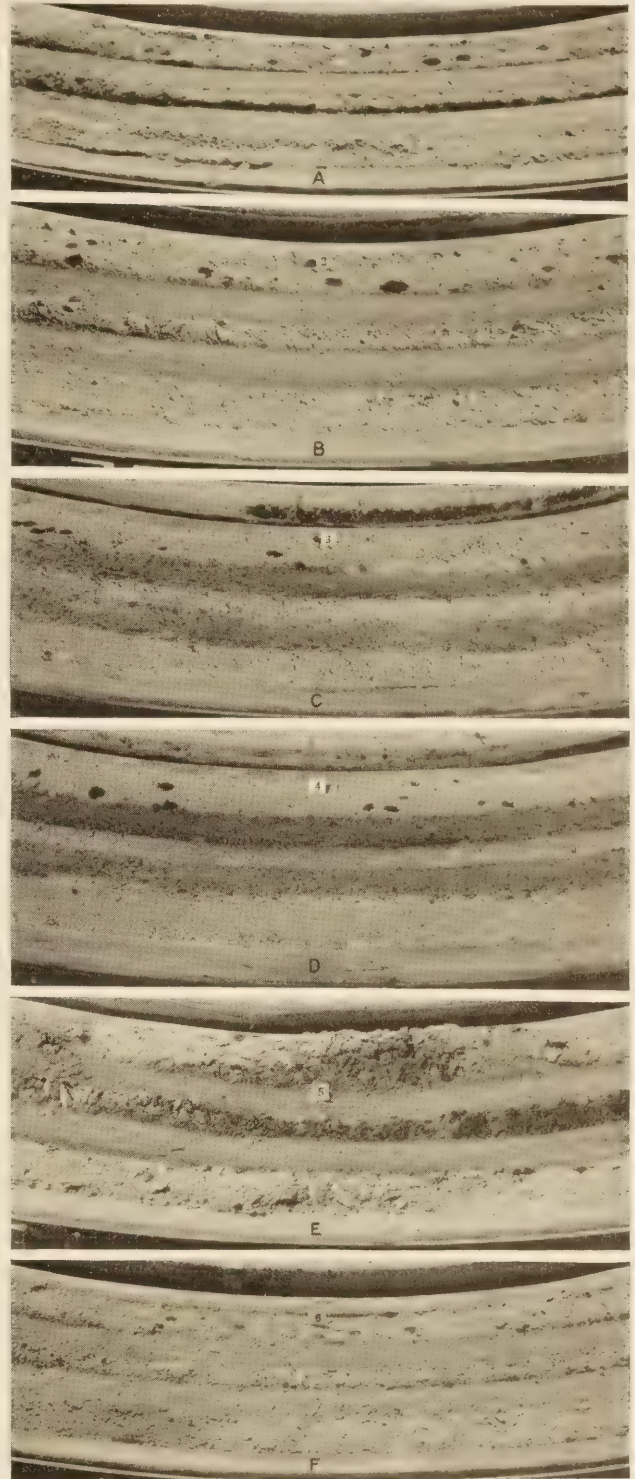
FIGURE 5.—APPEARANCE OF TEST SECTIONS AFTER 498,800 WHEEL-TRIPS. PICTURES A TO F CORRESPOND TO SECTIONS 1 TO 6, RESPECTIVELY.

had become unstable temporarily when tested with a treatment of waste sulfite liquor, was in the best condition of all the sections. Figure 5 shows the condition of the sections at the conclusion of the test.

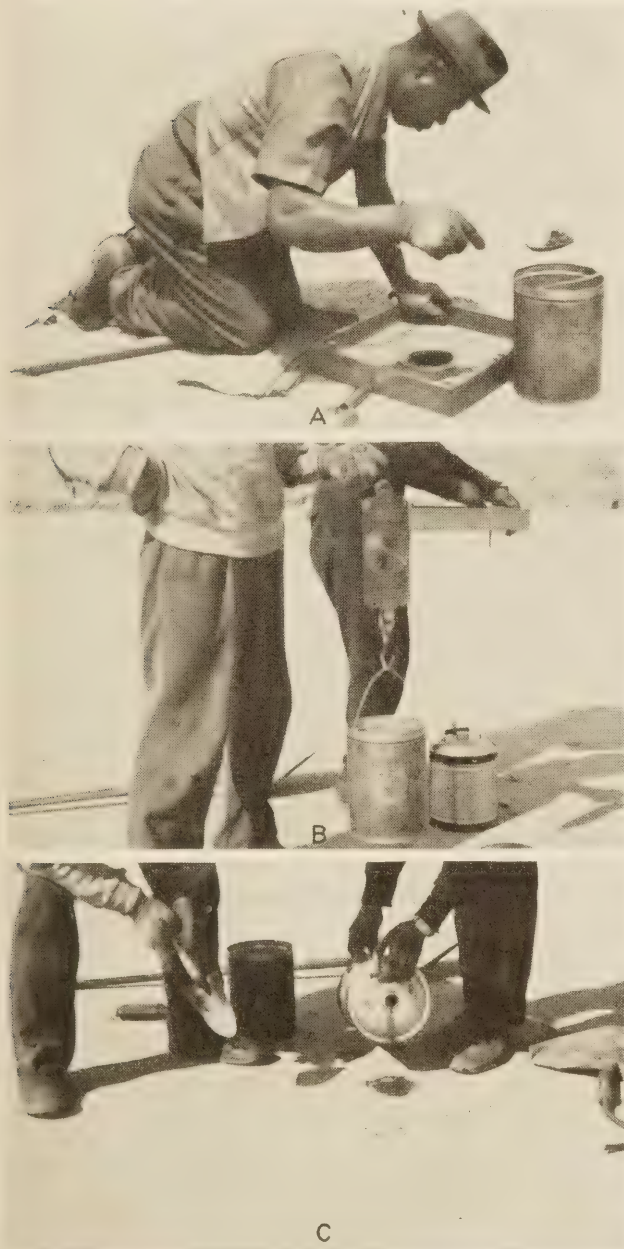
FIGURE 23.—THREE STEPS IN MAKING A DENSITY TEST: A, REMOVING LOOSENED BASE COURSE MATERIAL FROM HOLE; B, WEIGHING THE BASE COURSE MATERIAL REMOVED; and C, FILLING HOLE WITH OIL.

A soil collecting tray, 15 inches square, having a 4 1/2-inch circular opening in the center was set in place on the leveled surface (fig. 23-A) and a hole was dug through the compacted base by loosening the material with a trowel or pointed bar. The loosened material was scooped out with a large spoon, placed in a pail, and weighed on a spring scale of 30 pounds capacity (fig. 23-B). The indicator on the scale was adjusted for the weight of the pail so that the weight of the material removed from the hole was read directly. The moisture content of this material was then determined in the laboratory.

After all the loosened material had been removed, the hole was filled with motor oil (S. A. E. 40) from a 3-gallon can (fig. 23-C) and the can plus the oil remaining in it after filling the hole was weighed (fig. 24). The weight of the can plus the original volume of oil had been previously determined. The difference between the two weights gave the weight of oil in the hole. A hand suction pump was used to remove the oil from the hole.

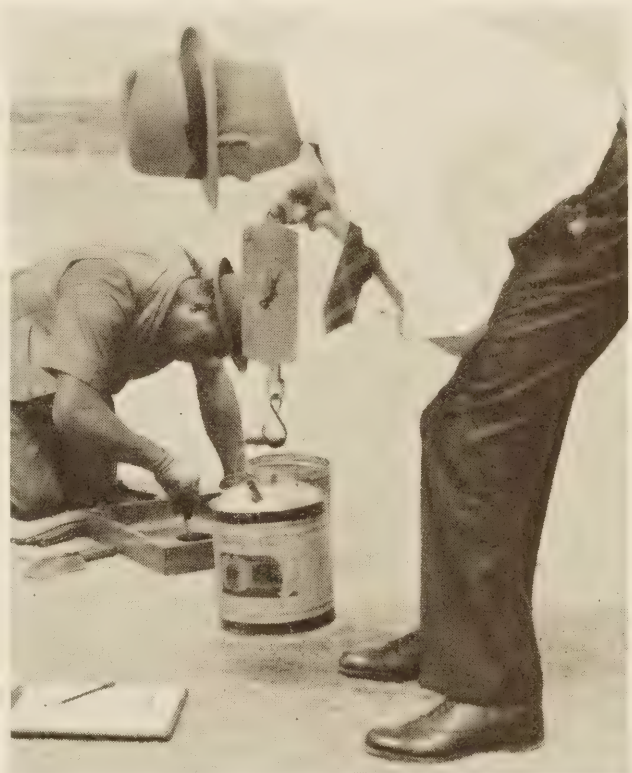
FIGURE 24.—BY DETERMINING THE WEIGHT OF OIL REMAINING IN THE CAN, THE WEIGHT AND VOLUME OF OIL REQUIRED TO FILL THE HOLE ARE DETERMINED.
